U.S. CHEMICAL SAFETY AND HAZARD INVESTIGATION BOARD

INVESTIGATION REPORT

STEEL MANUFACTURING INCIDENT

BETHLEHEM STEEL CORPORATION

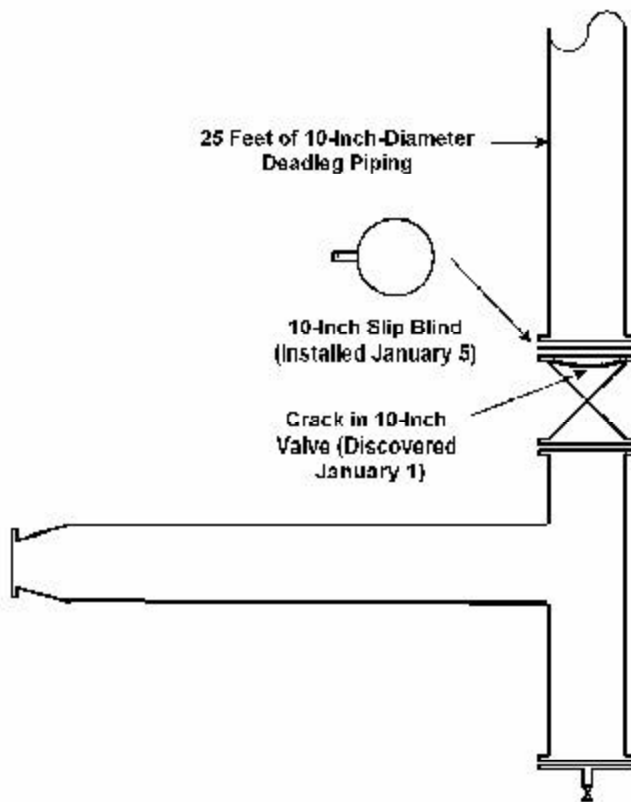
The #4 batch furnace in the 160-inch plate mill was shut down in 1992, at which time a 10-inch isolation gate valve was closed to prevent the flow of coke oven gas to the furnace. This created a 25-foot vertical deadleg⁴ of 10-inch-diameter piping above the valve, which was open to the COG distribution piping (Figure 5). Furnace demolition began in summer 2000.

Figure 5. #4 Batch furnace COG piping.

remained below freezing for most of December, a significant warmup late in the month allowed for thawing inside the furnace area. It is probable that any liquid in the deadleg drained through the crack before the gas was detected. As shown in Figure 5, the crack was located at the upper flange of the valve, above the gate that blocked flow.

The leaking valve problem was the subject of a meeting of supervisors from the plate mill and the utility departments between January 2 and 5. The managers decided to install a slip blind in the flange above the leaking valve (Figure 5) instead of the preferred blind flange and drain valve assembly. It would have taken additional time to fabricate the blind flange and drain valve, and the plant wanted to switch more quickly from natural gas to the less expensive coke oven gas.

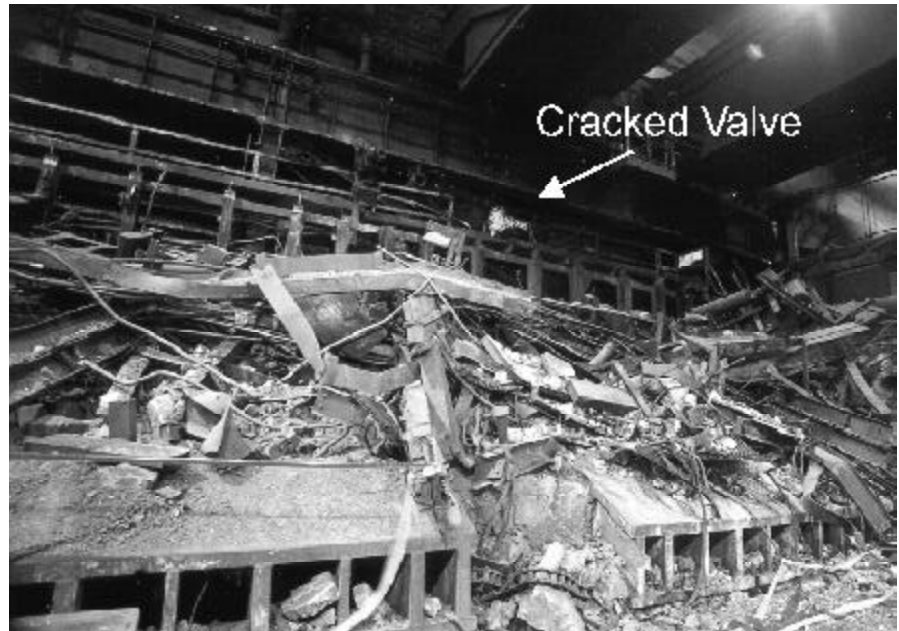
Over the Thanksgiving 2000 weekend, the furnace structure was knocked down. Figure 6 shows the resulting rubble pile.

Figure 6. #4 Batch furnace debris pile present before incident.

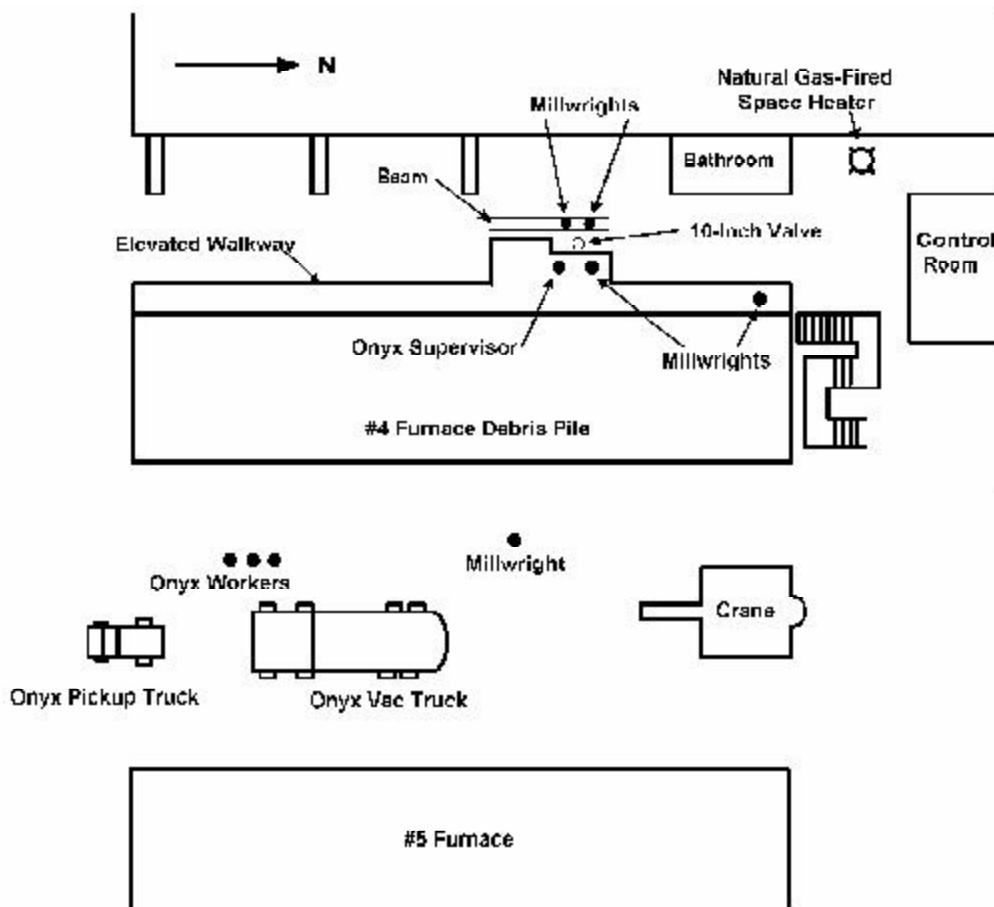
At this time, the workers were located as shown in Figure 7. Two millwrights were balanced on the piping behind the valve, off the walkway. Another millwright was standing on the walkway. The Onyx supervisor was standing to the side of the valve. The fourth millwright was working near the end of the walkway, and the fifth millwright and three of the Onyx personnel were located on the ground.

Figure 7. Location of personnel at time of release, February 2, 2001.

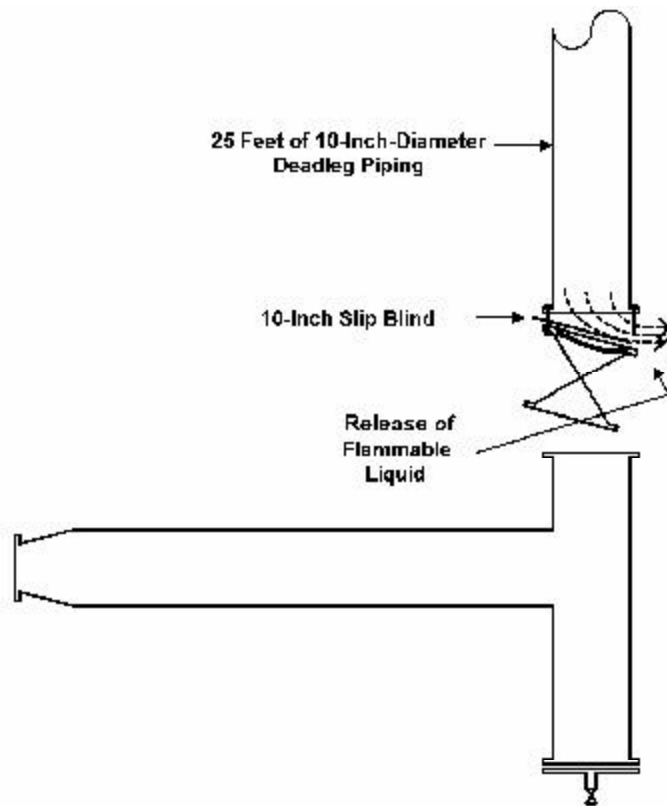
Figure 8. #4 Batch furnace COG piping, release of flammable liquid, February 2, 2001.

along the wall to the south, toward the valve. As the flame reached the valve and the open pipe, there was a blast and flammable liquid sprayed in all directions.

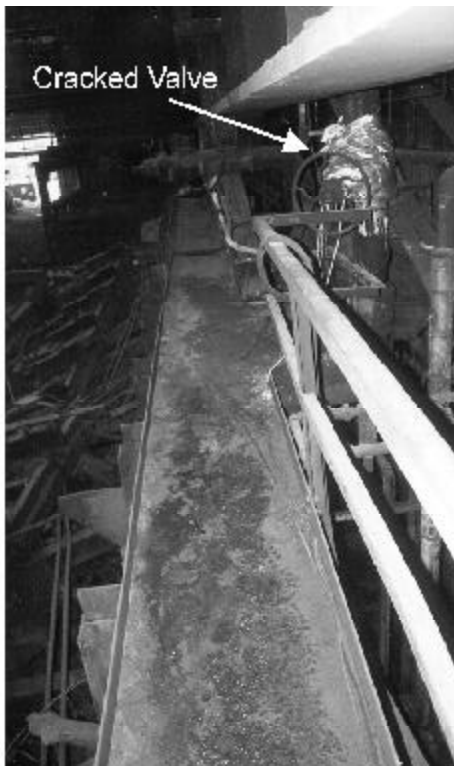
- No railing was in place on the east side of the walkway; there was a 6-foot drop from the walkway to the rubble pile (Figure 9).
- Piping from the demolition blocked the stairway landing to the walkway.
- The stairway did not connect with the walkway.

These obstructions and lack of handrails made it difficult for workers to escape the area when the leak and fire started. It is probable that the loss of life and injuries would have been lessened if an easier means of exit was available. The job planning process should have addressed exit routes.

Figure 9. Elevated walkway looking south (note absence of handrail on left side).

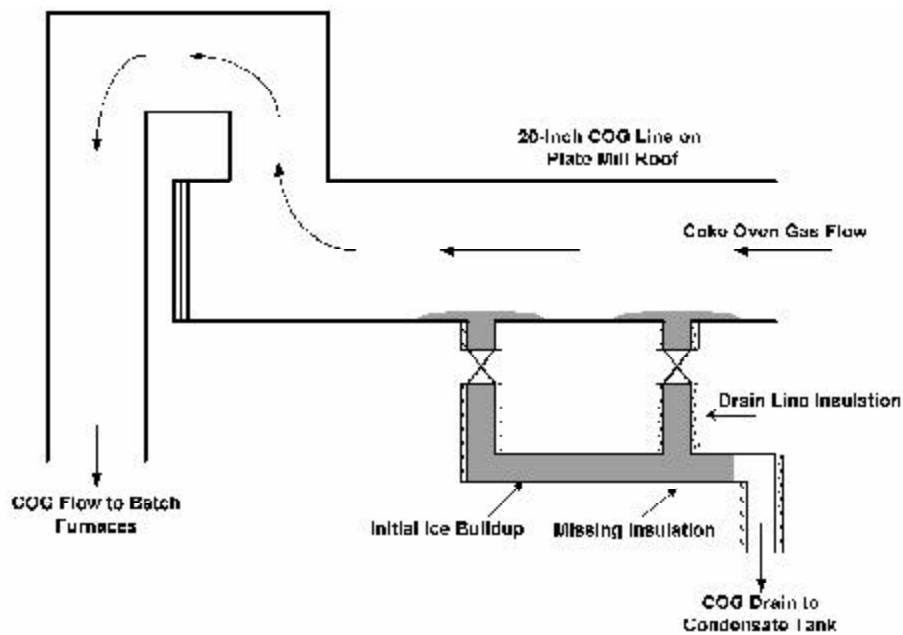
Figure 10. Probable flammable liquid buildup scenario—ice formation.

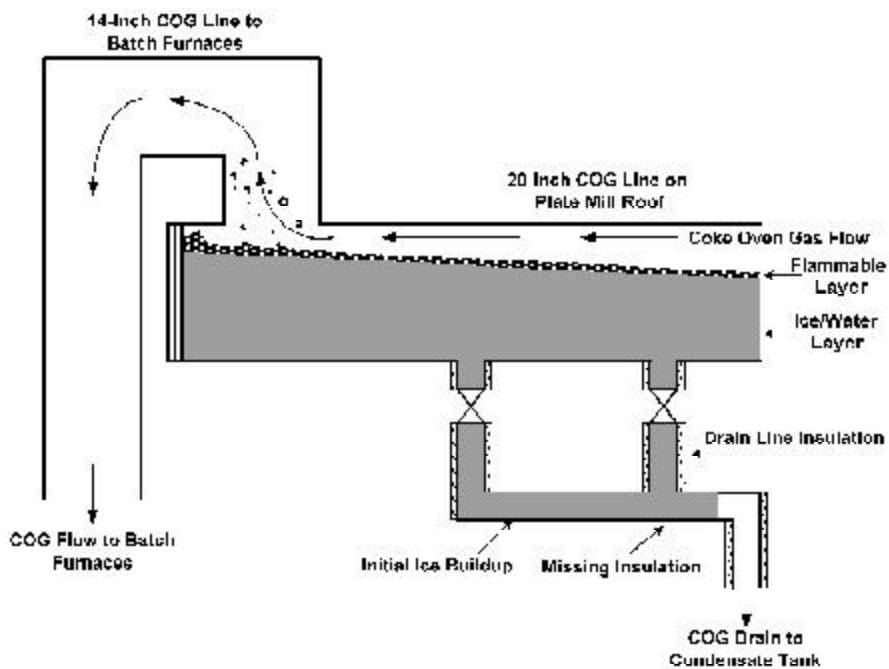
Figure 11. Probable flammable liquid carryover scenario.
